## DEFECT INFORMATION REPORT #638

The secondary hood latch rod may bind on the guide bracket and prevent secondary latch engagement. If this condition occurs simultaneously with a not engaged primary latch, the hood may not be restrained.

### **DEALER SERVICE INSTRUCTIONS Safety Recall #638 – Secondary Hood Latch Bracket**

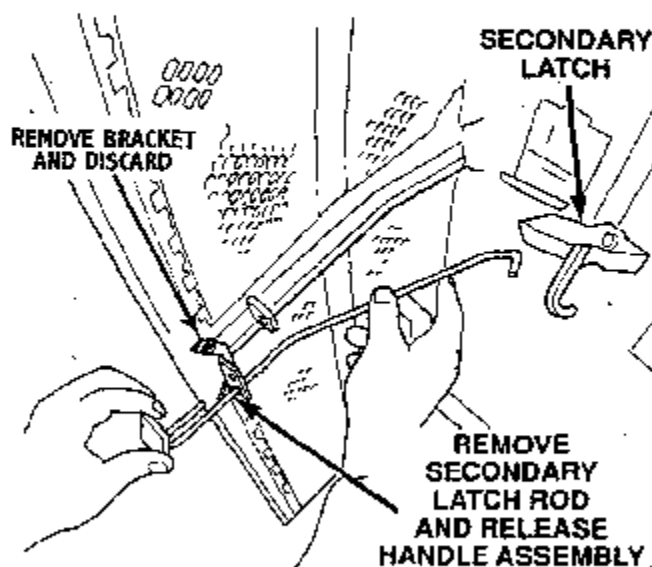
Figure 1

The secondary hood latch rod may bind on the guide bracket and prevent secondary latch engagement. If this occurs when the primary (main) latch is not engaged, the hood may fly open when the vehicle is being driven. To correct this condition, the secondary hood latch bracket must be replaced.

1. Open hood, then unclip and remove the secondary latch rod and release handle assembly (Figure 1).
2. Remove two (2) screws holding the bracket assembly to grille support, then discard the bracket and screws (Figure 1).

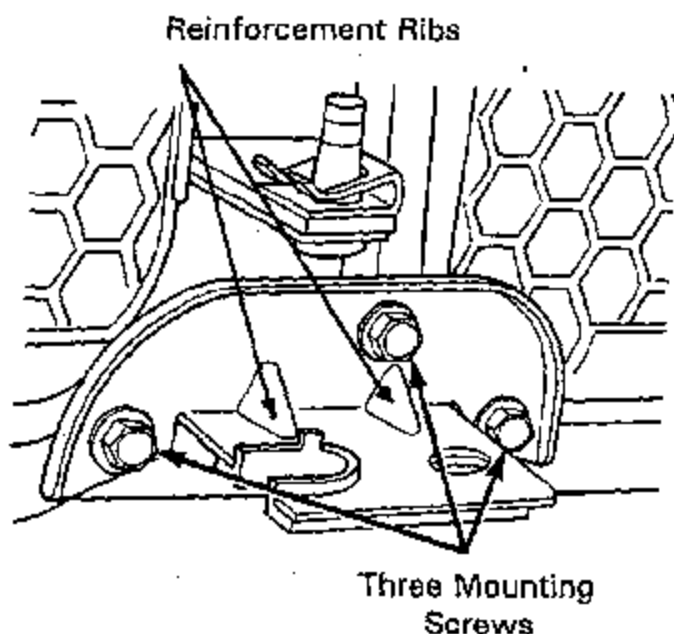
Figure 1

- A2. The subject vehicle remedy guide bracket (figure 1) utilizes three mounting screws and additional reinforcement ribs for improved strength. The December, 1994 production remedy utilizes the same guide bracket as that used at the beginning of the 1994 model year (figure 2). The initial (and December, 1994 production fix) guide bracket is mounted with two screws and is bent at a 90 degree angle. The subject vehicle guide bracket (beginning late-January, 1994) is mounted with two screws and is bent at an 84 degree angle (figure 2). This six degree angle bracket modification reduces clearance between the hood latch rod and guide bracket and creates the potential for rod-to-bracket binding on the subject vehicles.
